# **INDOOR AIR QUALITY ASSESSMENT**

**James Leo McGuinness Administration Building  
Lynn Public Schools  
14 Central Avenue  
Lynn, Massachusetts**

Prepared by:  
Massachusetts Department of Public Health  
Bureau of Environmental Health Assessment  
February, 2002

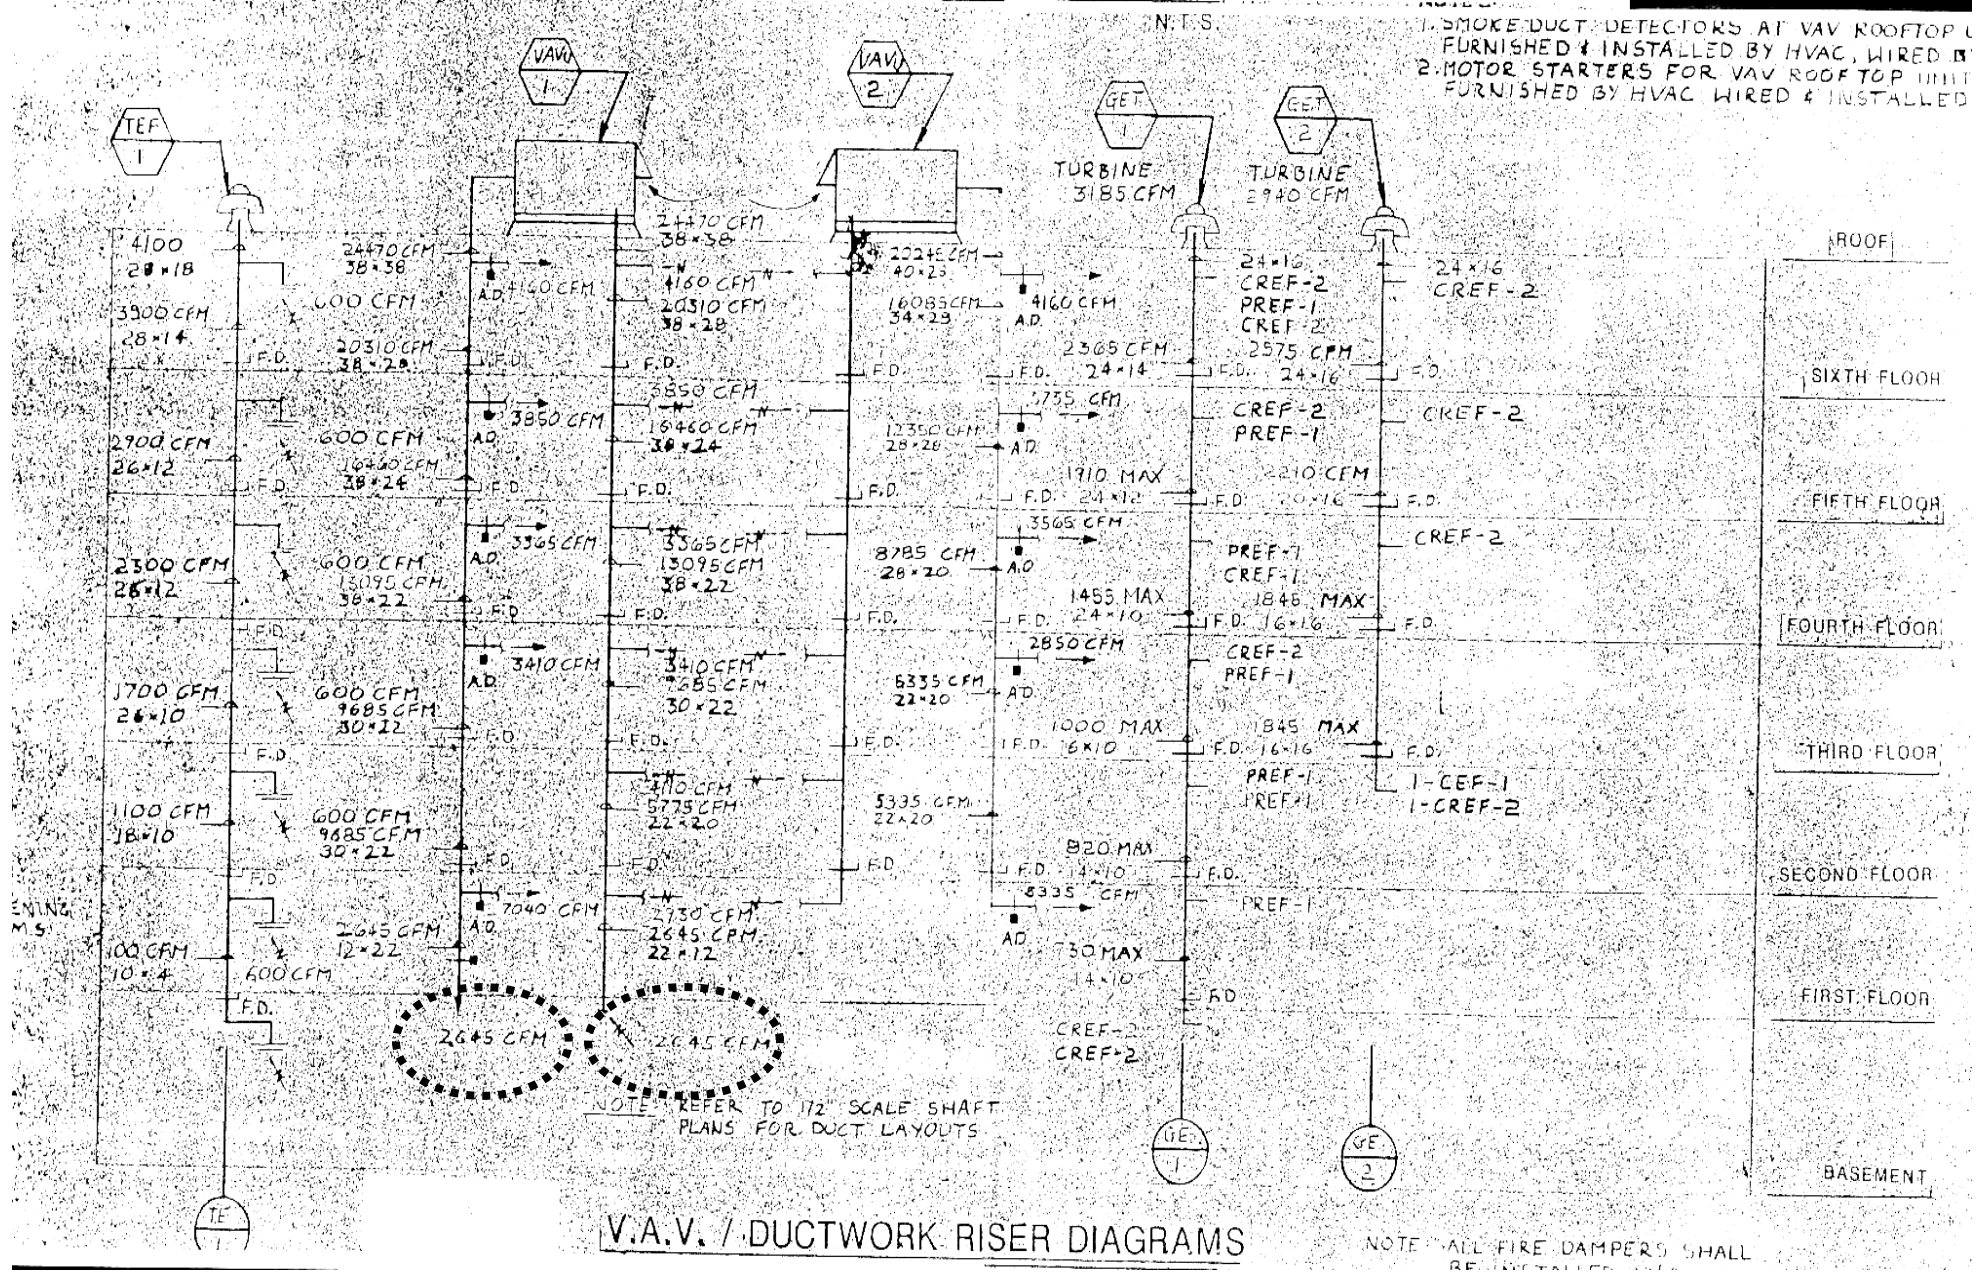
# Blueprint 1

The entire building was originally designed to have fresh air supplied by two roof-mounted AHUs (see Blueprint 1). In the original configuration, it appears that ductwork connected to “VAVU 1” provided fresh air for the basement area. Subsequent renovations appear to have replaced the original system with a single AHU. The original ductwork, however, remains in place, connected to the basement. If this ductwork draws air from the basement, pollutants present in the records storeroom (see Microbial/Moisture Concerns section of this report) can be drawn into the ventilation system and distributed to occupied areas of the building.

Blueprint Indicating Basement Connection to Main HVAC System Ductwork

6. Continue with efforts to separate the building's HVAC system from the basement record storage area.
7. Remove leaking batteries from the basement.
8. Examine each fresh air diffuser for function. Survey offices to ascertain if an adequate air supply exists for each room.

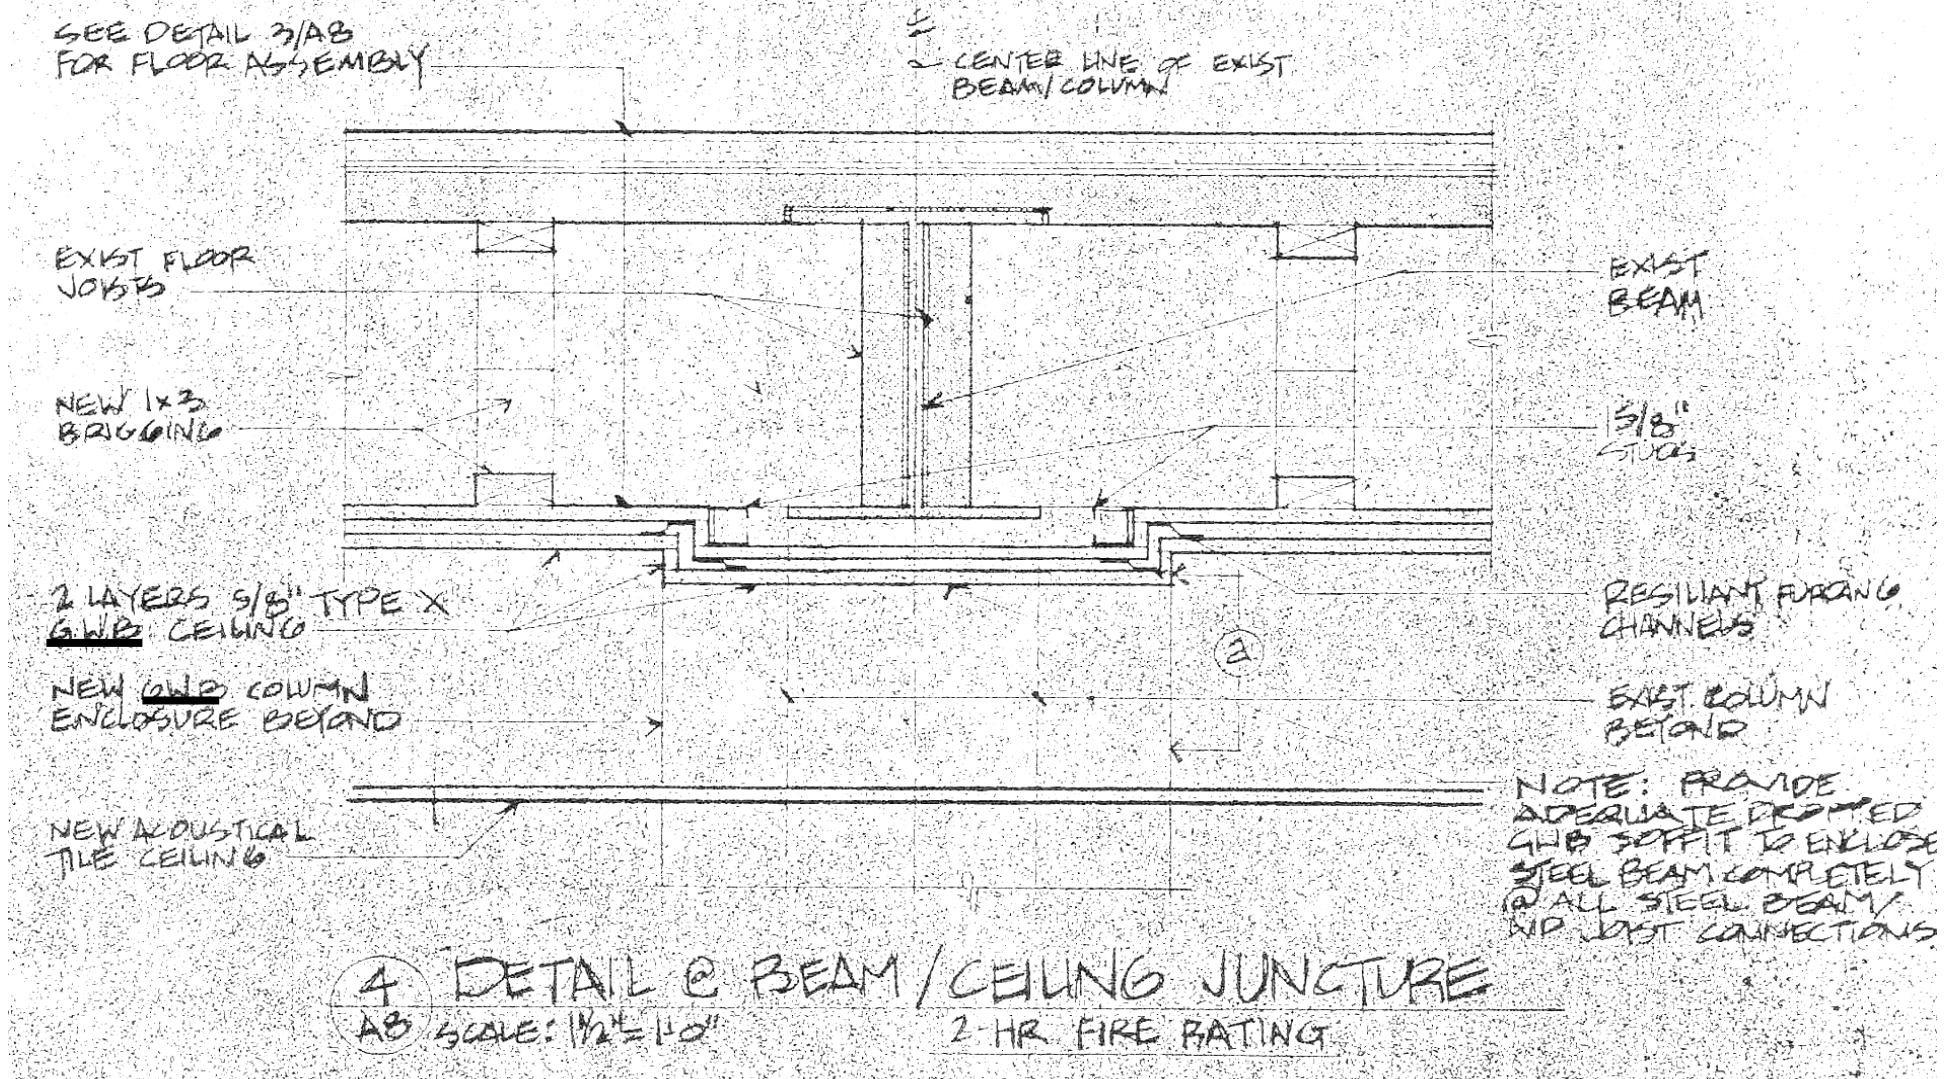
## Blueprint 2

**Detail of Beam/Ceiling Junction. Note use of GW above Acoustical Ceiling Tiles**  
 GWB on Blueprint = Gypsum Wallboard

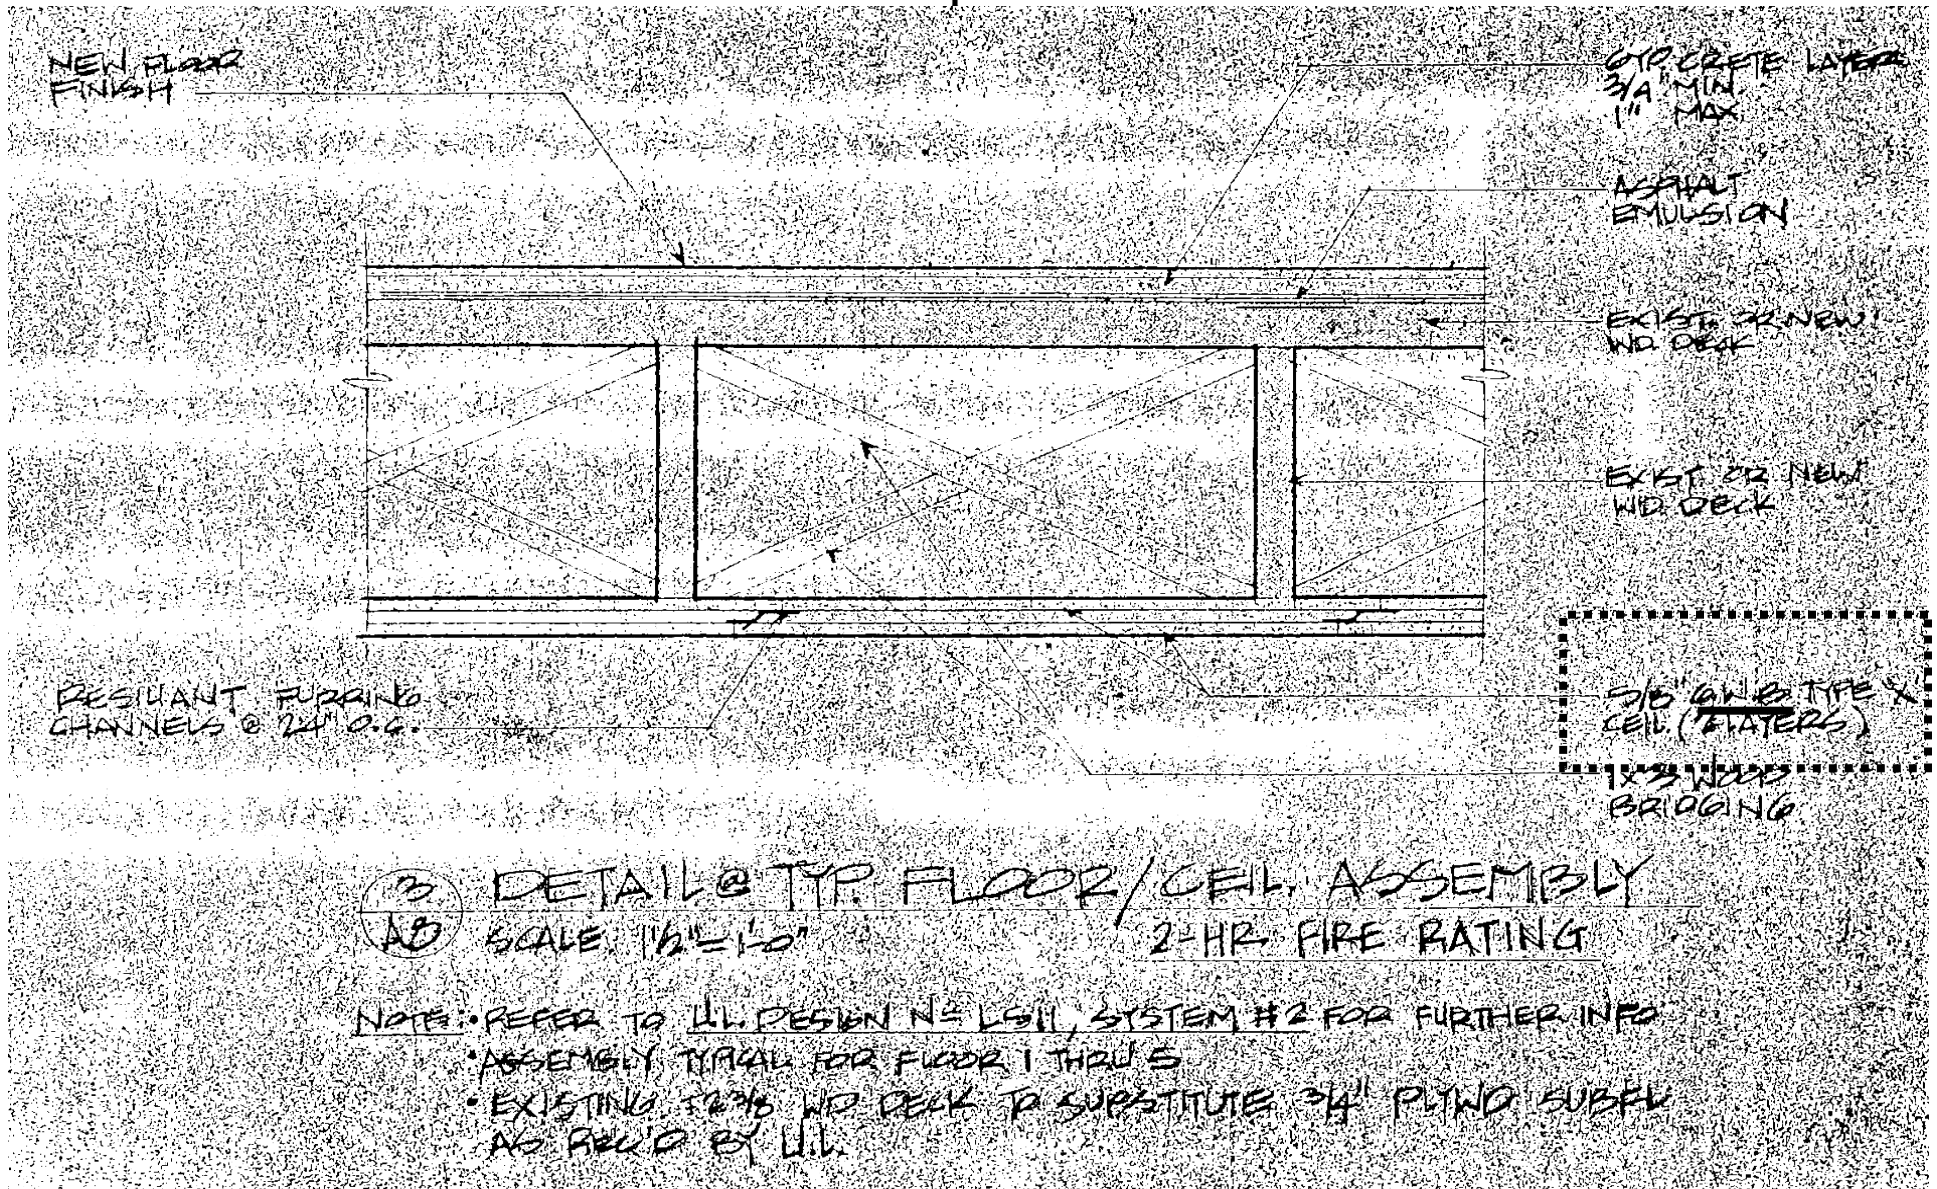
# Blueprint 3

Detail of Wall Assembly. Note use of GW to Provide "2-Hr Fire Rating"

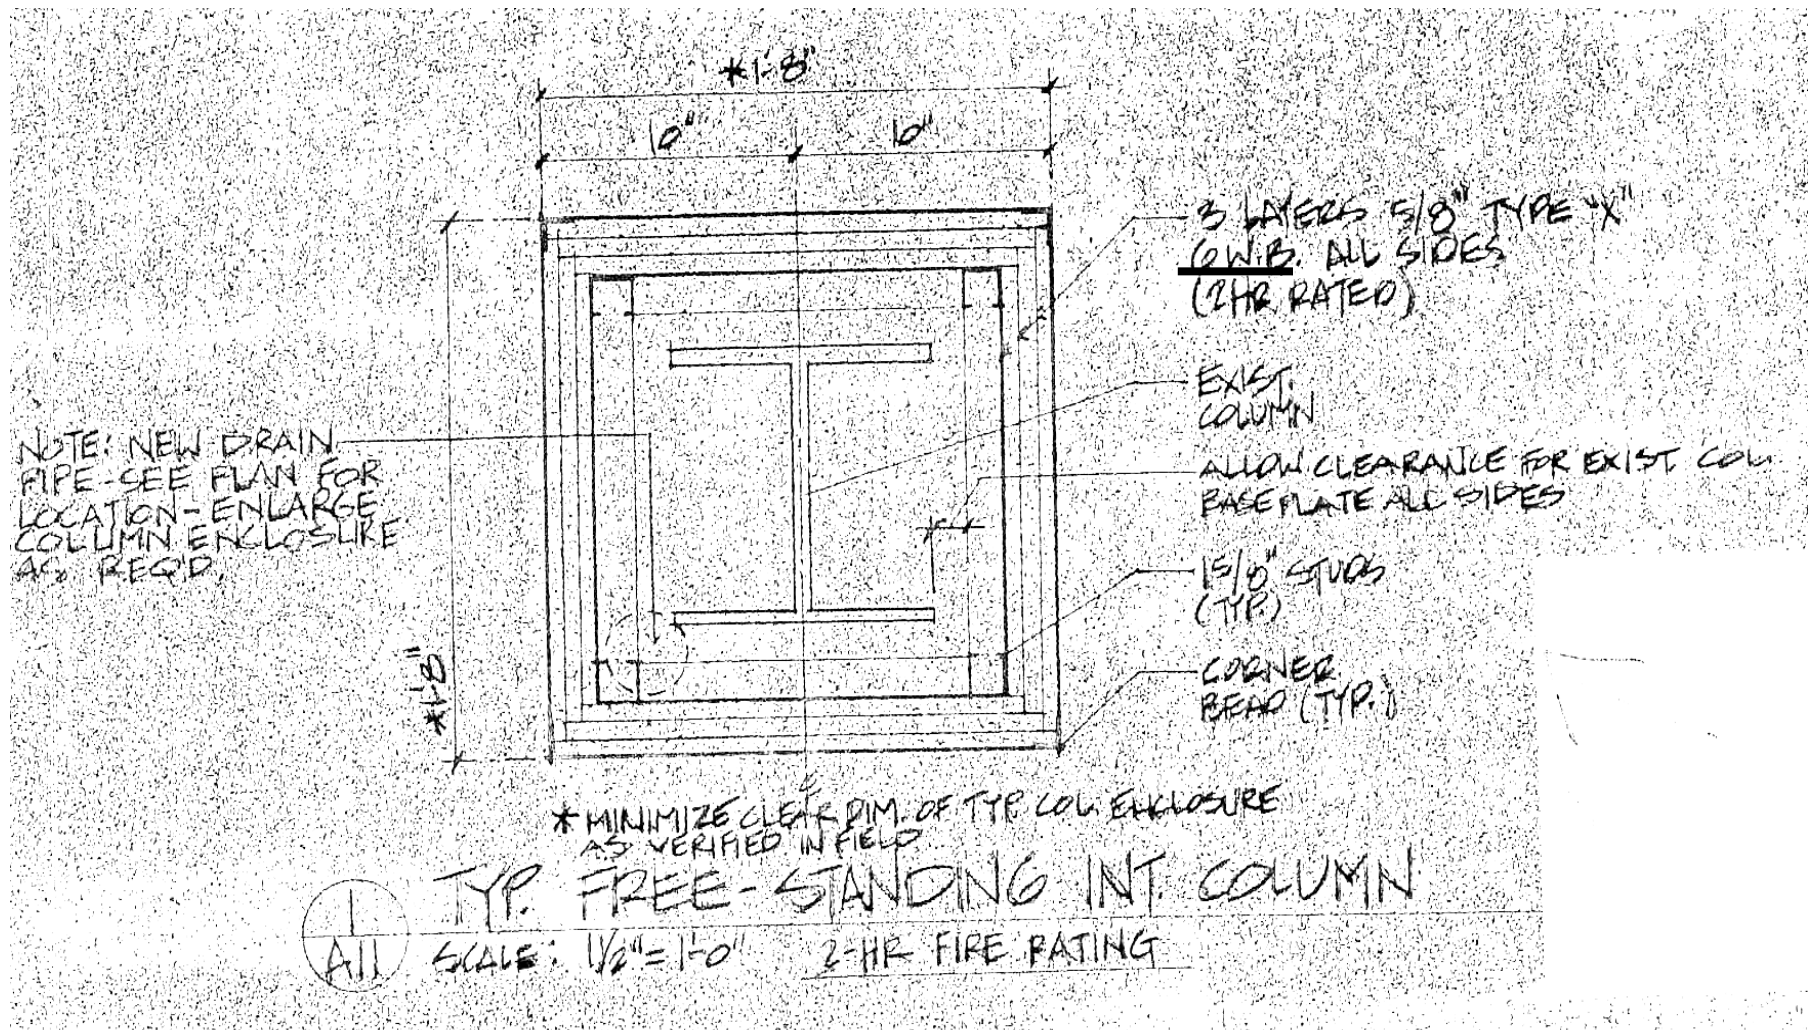
# Blueprint 4

Signs of water damage also exist in the 4<sup>th</sup> and 5<sup>th</sup> floor elevator foyers. Water damaged ceiling tiles were observed around the west support pillar in each elevator foyer. Each pillar contains a steel-I-beam that is sealed within a GW box (see Blueprint 4). BEHA staff drilled a hole in the GW pillar-box on Floors 6, 5 and 4 to examine the interior surface of GW. I-beams were heavily corroded with rust. Water stains were noted on GW on each floor. GW and metal frames appeared to be covered on one surface with white, splotchy materials, which may be mold contamination. Each pillar-box appeared to draw GW dust created by drilling *into* each pillar, indicating that the pillars are open to the ceiling plenum of each floor. Spores from possible fungal contamination can also be drawn into the ceiling plenum. With poorly installed filters, these possible sources of microbial growth can be distributed to occupied areas of the building. Since this assessment, LPS officials reported that the repeated leak moistening the GW was traced to the roof of the elevator shaft. Efforts were reportedly made to repair the leak to prevent further water damage.

**Detail of Pillar Assembly in Elevator Foyer. Note use of GW to Provide "2-Hr [Fire] Rating"**  
 GWB on Blueprint = Gypsum Wallboard

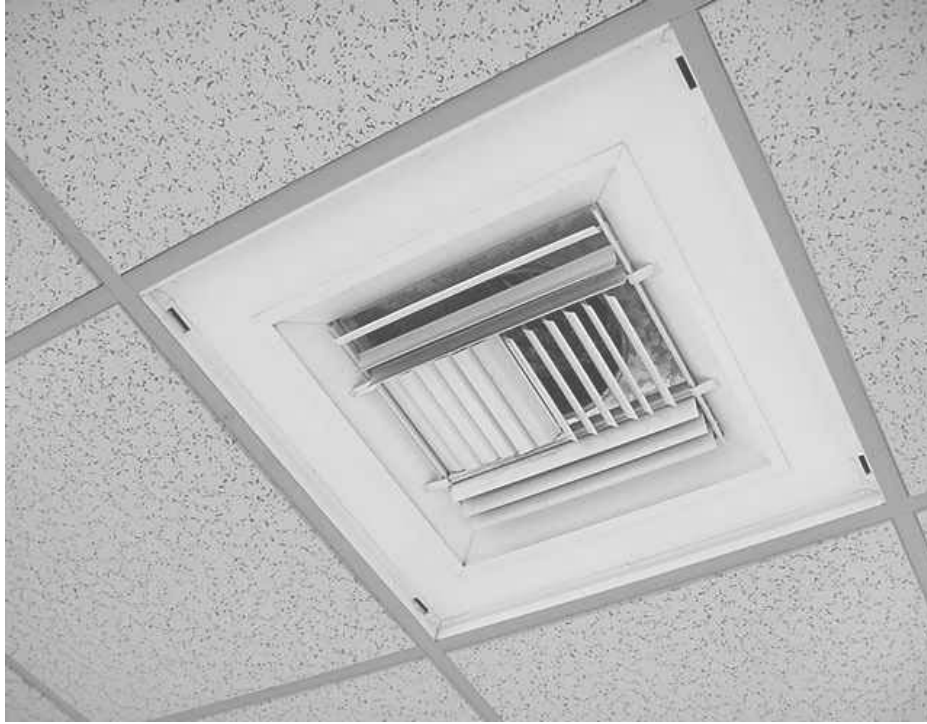
**Picture 1**

**Air Diffusers Have Louvers Directed Downwards**

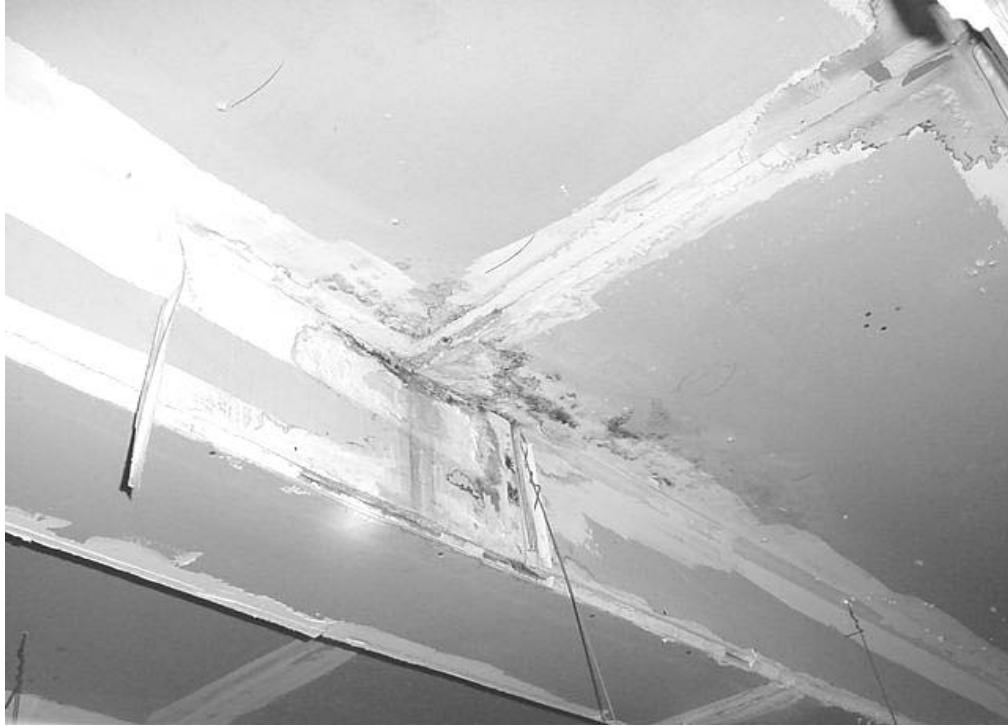
**Picture 2**

**Seams of Joined GW in the Ceiling Plenum.  
Note Blackened Area Which May Indicate Mold Growth**

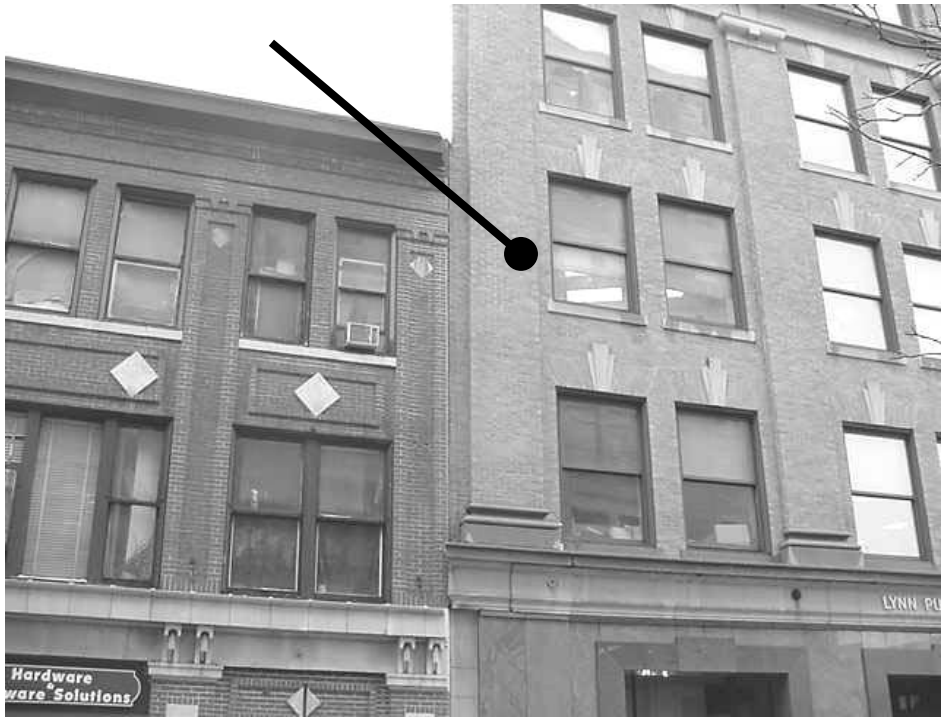
Picture 3

Original Redbrick Above the First Floor

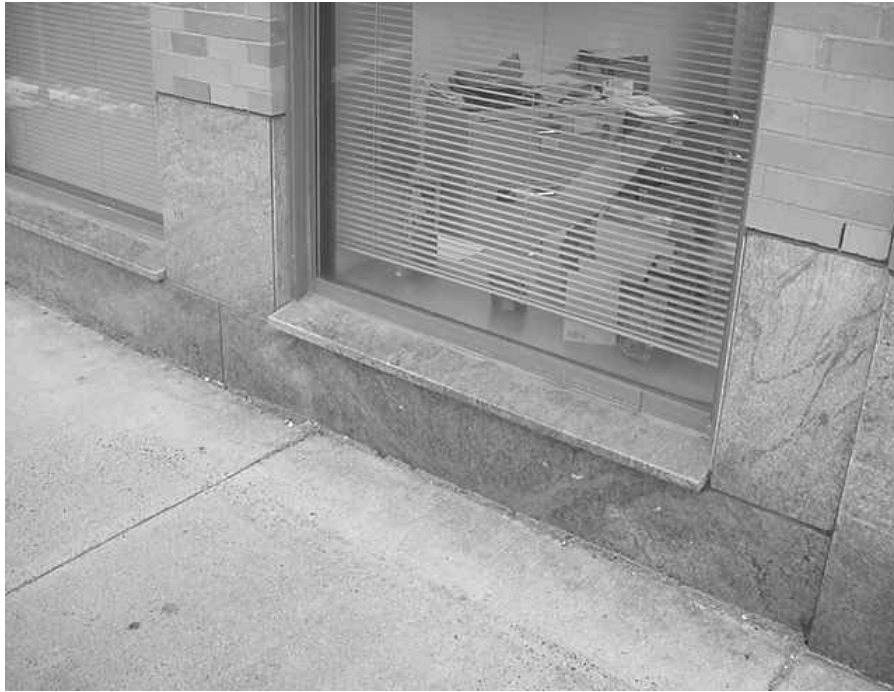
**Picture 4**

**Red Granite Exterior Wall**

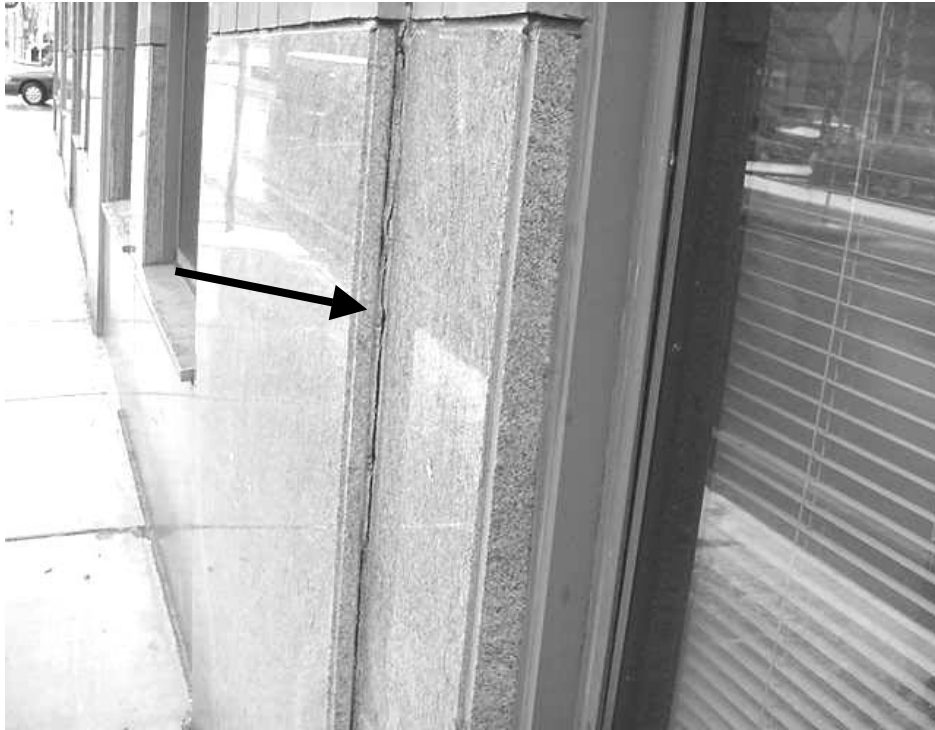
**Picture 5**

**Shrunken Sealant Material between Red Granite Slabs**

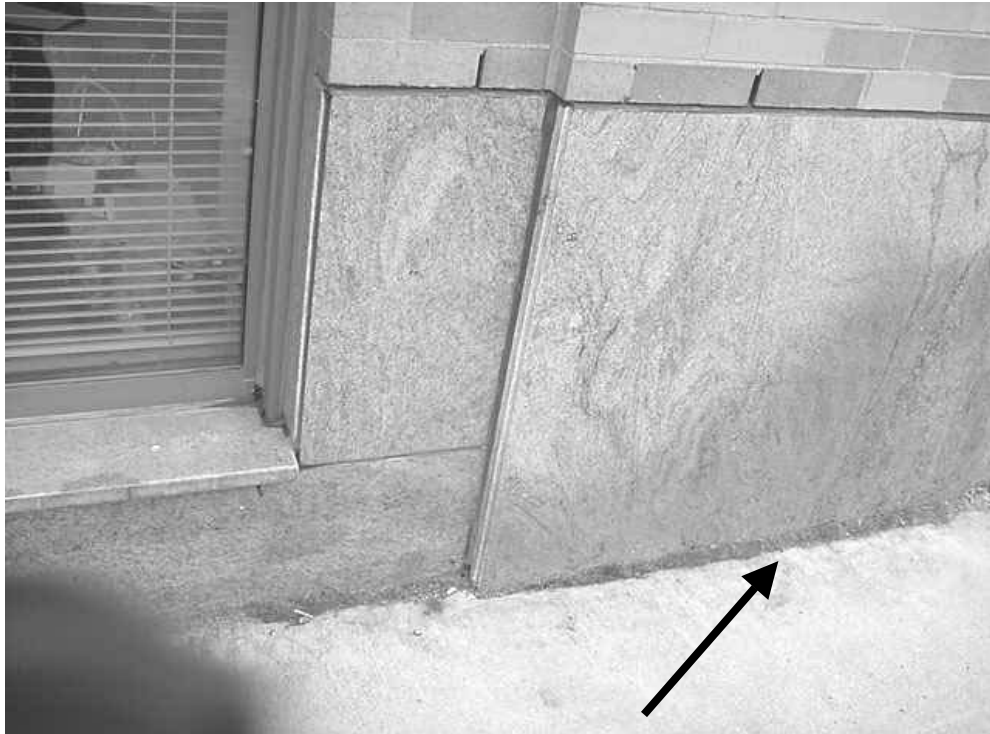
**Picture 5A**

**Moss on Sidewalk/Granite Slab Sealant**

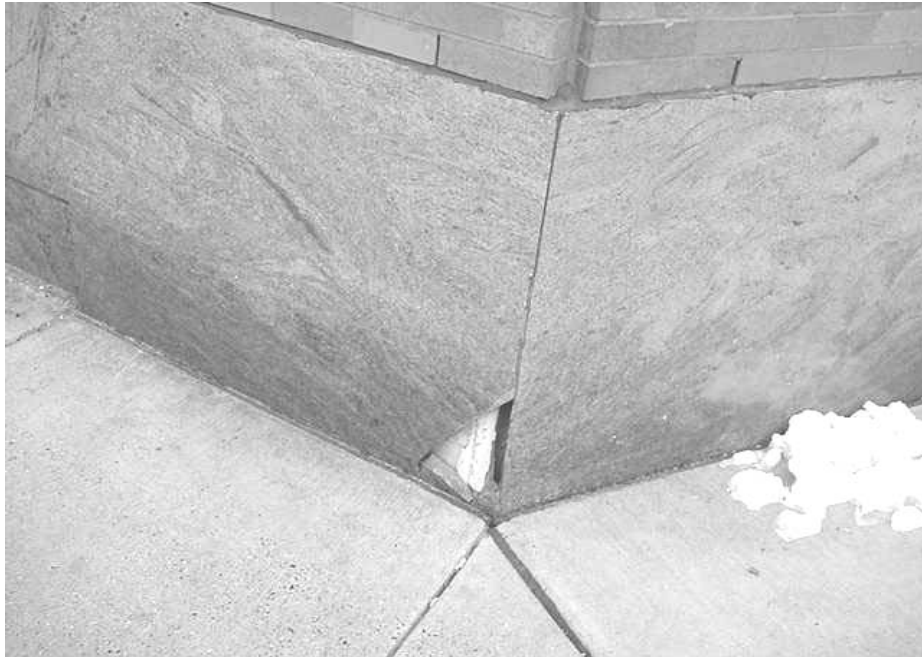
**Picture 5B**

**Broken Granite Slab Exterior Panel**

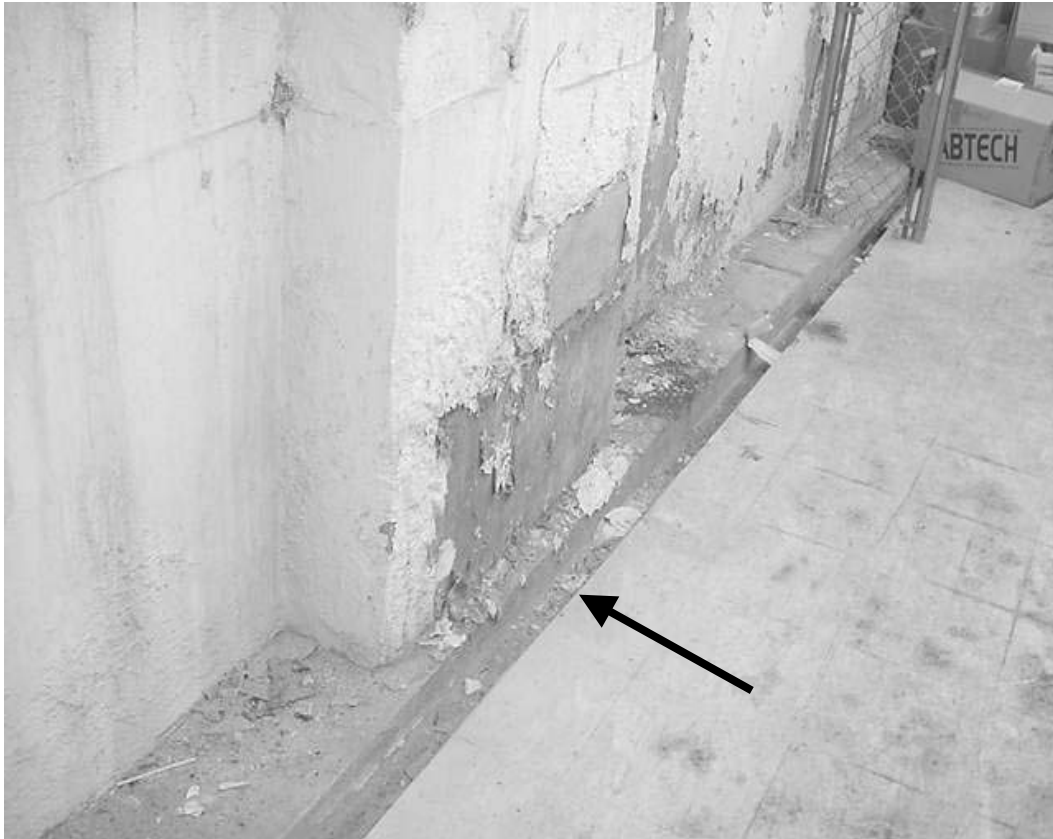
**Picture 6**

**Trench in Basement Floor. Note Peeling Paint on Foundation Wall**

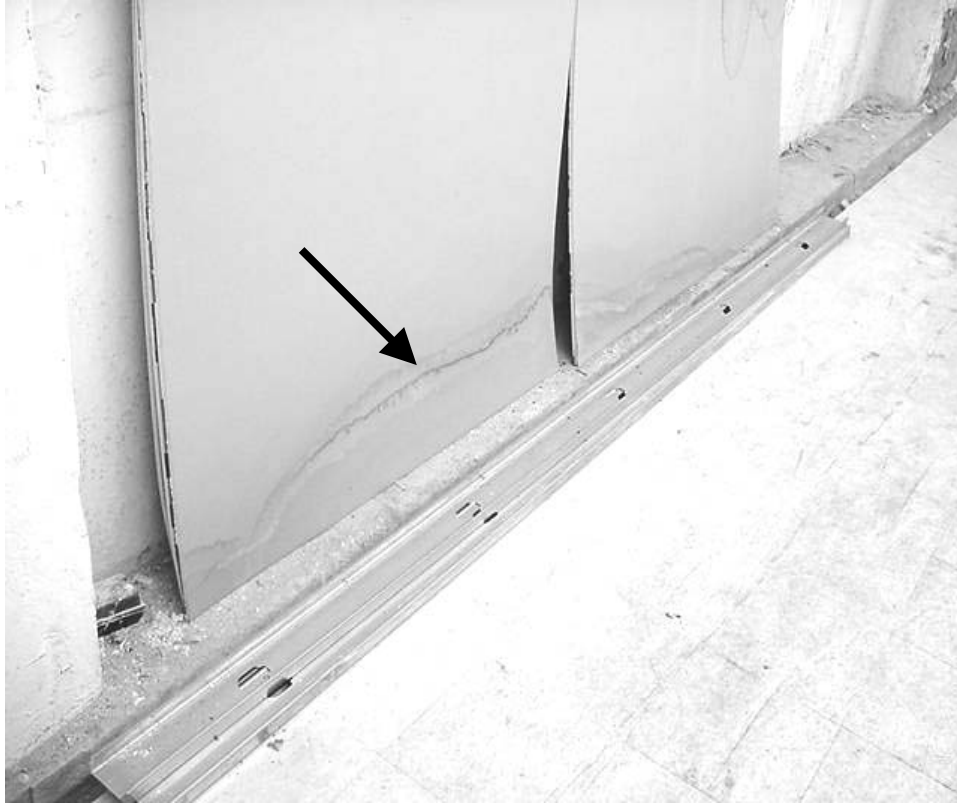
**Picture 7**

1. Paper records,
2. Cardboard boxes,
3. Debris in the drainage trench (see Picture 7);
4. Paint,
5. Pipe insulation,
6. Furniture and cloth floor dividers and
7. Ceiling tiles.

**Trench in Basement. Note Accumulated Debris in Trench and Multiple Water Stain Lines on GWB**

11. Clean debris from the interceptor drain in the basement floor.
12. For buildings in New England, periods of low relative humidity during the winter are often unavoidable. Therefore, scrupulous cleaning practices should be adopted to minimize common indoor air contaminants whose irritant effects can be enhanced when the relative humidity is low. To control for dusts, a high efficiency particulate arrestance (HEPA) filter equipped vacuum cleaner in conjunction with wet wiping of all surfaces is recommended. Avoid the use of feather dusters. Drinking water during the day can help ease some symptoms associated with a dry environment (throat and sinus irritations).

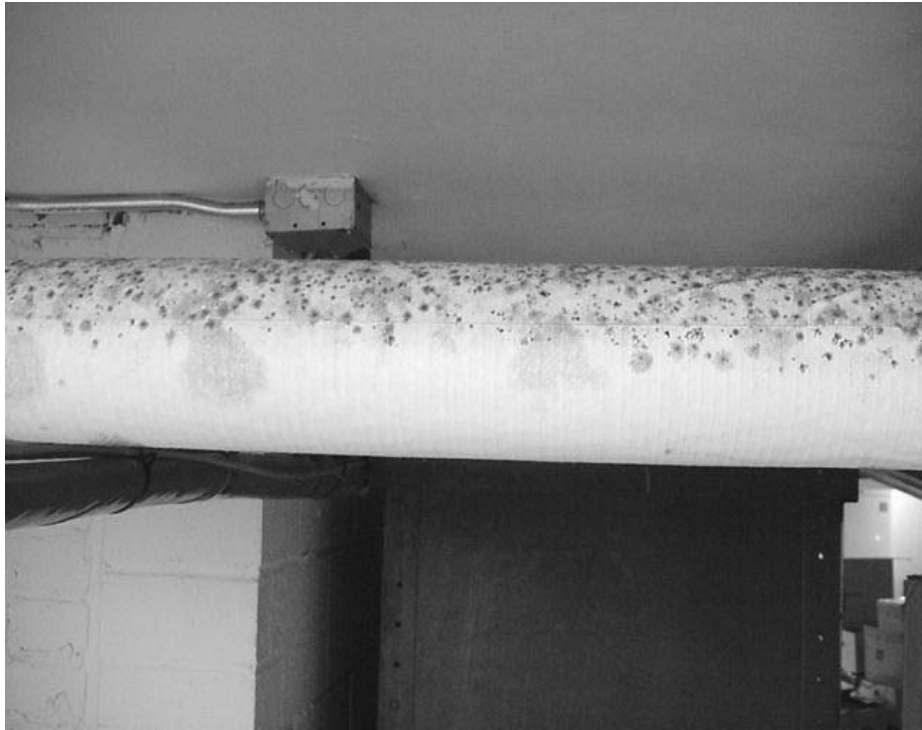
**Picture 8**

All of these materials can support mold growth if subjected to moisture. Of note is the condition of pipe insulation, which was found spotted with visible mold colonies (see Picture 8). The persistence of mold on pipe insulation, when considered with the condition of foundation paint and water in the elevator shaft indicate that moisture pathways exist in the basement. As with GW, if porous materials are not dried within 24 hours, mold growth may occur. Water-damaged porous materials (e.g., carpeting and pipe insulation) cannot be adequately cleaned to remove mold growth, unless extraordinary remediation measures are used. As previously discussed, the application of a mildewcide to porous materials is not recommended.

**Mold Colonized Pipe Insulation in the Basement**

13. Replace mold colonized pipe insulation.

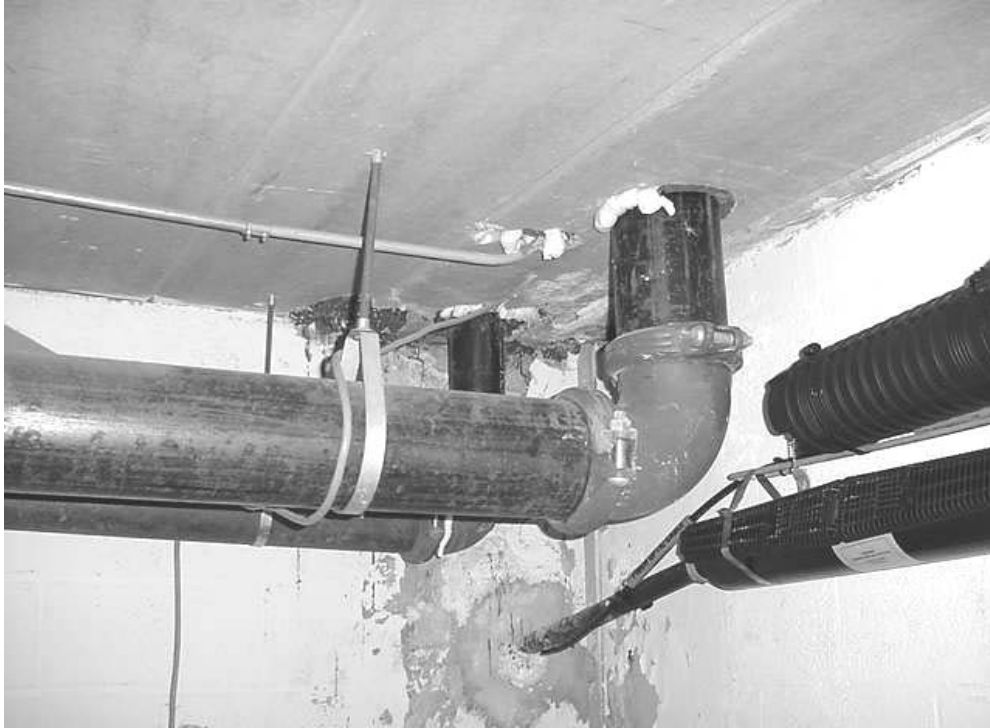
**Picture 9**

**Penetration in Basement Ceiling, Which was Sealed by RMR Consultant**

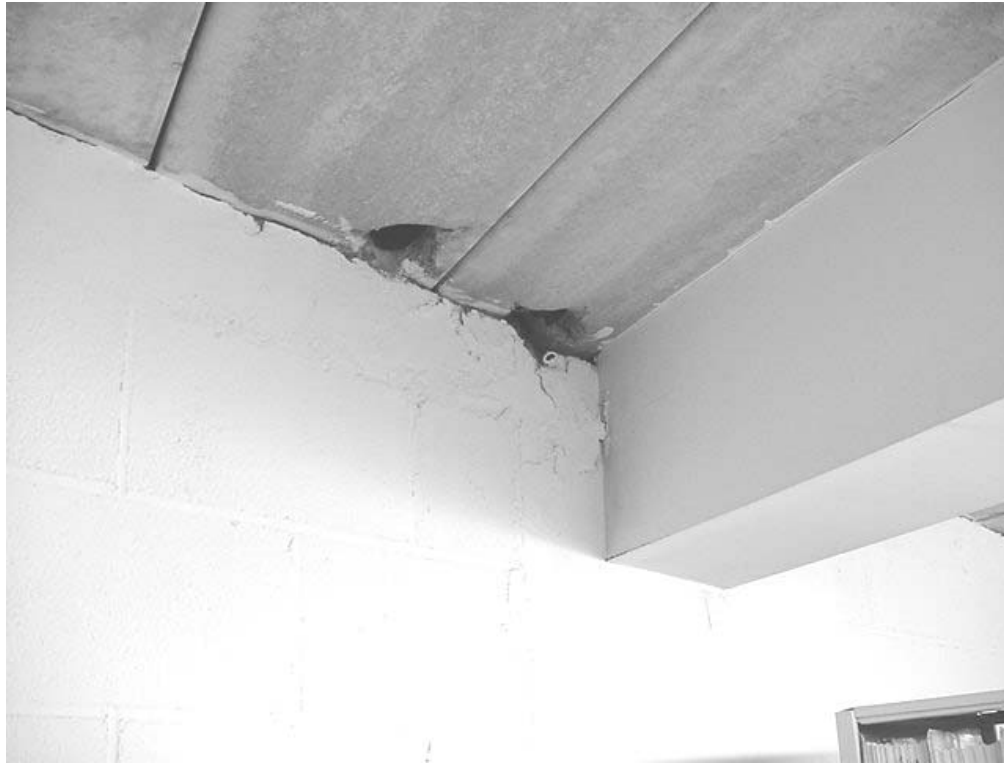
**Picture 10**

building utilities (see Pictures 9 and 10 as representative examples). These holes may serve as a pathway for basement pollutants to migrate into the first floor office area. The connection of the ventilation system may draw basement pollutants into the return system for the rooftop AHU. With poorly installed filters, these pollutants may be redistributed to occupied areas of the building.

**Penetrations into Basement Ceiling**

9. Consider having the systems balanced by an HVAC engineering firm.
10. Seal all abandoned pipes entering into the basement from the outdoors. Seal all pipe, conduit and other penetrations through the basement ceiling that penetrate into the 1<sup>st</sup> floor office space.

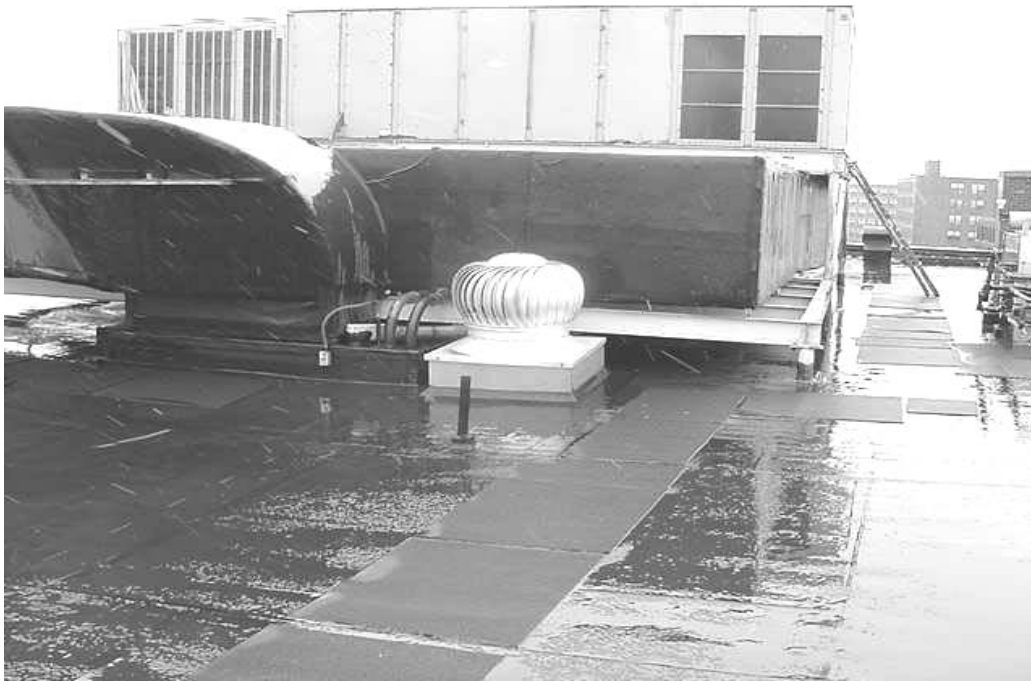
**Picture 11**

Two wind-driven turbine fans exist on the roof, which appear to be part of the original exhaust ventilation system (see Blueprint 1, Picture 11). As reported by RMR staff, the installation of the rooftop AHU provides exhaust ventilation, thus rendering these vents obsolete. Since each of these vents can be a route for uncontrolled air/moisture to enter the building, sealing these vents may be advisable if they serve no purpose.

**Turbine Vent on Roof**

1. Consider removing/sealing the turbine exhaust vents on the roof if their purpose was rendered obsolete.
2. Removal of the water damaged GW above the 6<sup>th</sup> floor foyer should be considered. Consult a building engineer as to what materials may be used other than GW to provide fire resistance.
3. Consult a building engineer to examine options for repairing the seal in the granite exterior wall system. Repairs may include replacement of damaged slabs.
4. Consult a building engineer as to the best method for preventing or minimizing water penetration through the foundation.
5. Repair/replace windows that are inoperable or difficult to open.

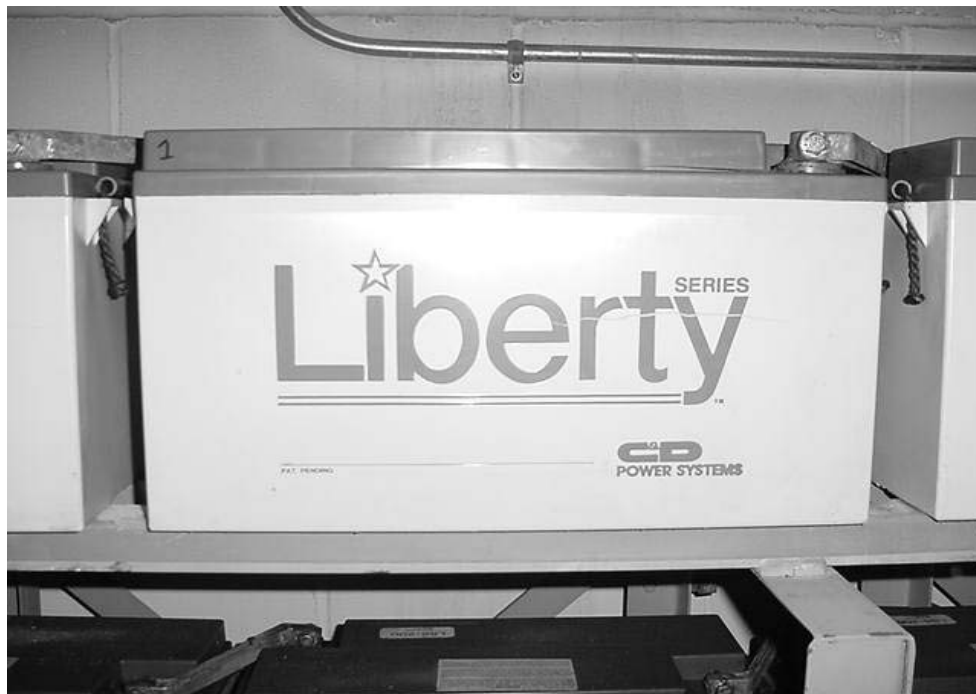
**Picture 12**

Several other conditions that can effect indoor air quality were noted during the assessment. In the telephone room of the basement is a shelf on which a number of batteries are stored (see Picture 12 and 12A). It was reported that these batteries were used as an emergency backup for the building's telephone system. This backup system is now reported by RMR to be obsolete. Corroded pipes and metal above the batteries may indicate they are leaking acid. The battery solution would be expected to be a dilute

**Batteries in Basement Telephone Room**

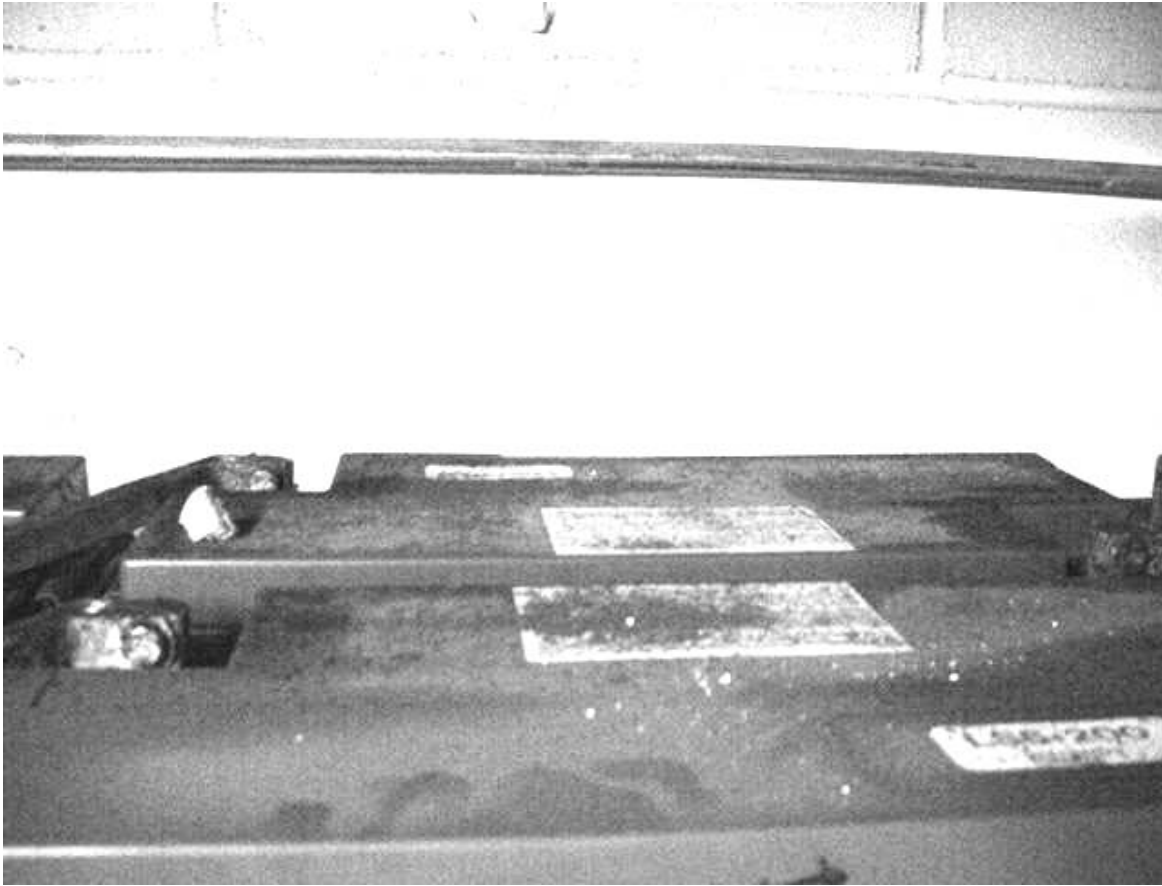
**Picture 12A**

sulfuric acid solution. This mixture evaporates over time, which can form a vapor of sulfuric acid and water. Dilute sulfuric acid can be irritating to the eyes, nose and throat.

**Rust From Corrosion on Top of Batteries**

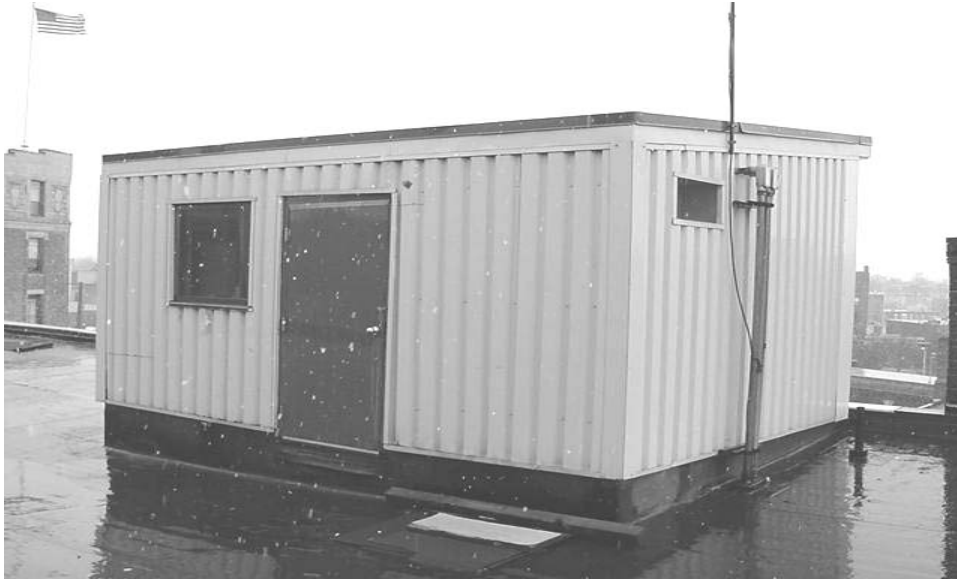
**Picture 13**

5. Lynn school officials report that RMR identified the leak in the roof of the elevator penthouse (see Picture 13) as a possible continued source of water that is staining ceiling tiles in the 6<sup>th</sup> floor foyer. Efforts are in progress to remediate this leak.

**Elevator Penthouse on Roof**
